# Characterization Of The Effects Of Armor Weight Cab And Door Structure Of Medium Tactical Vehicles

Eric O'Brien  
RDECOM - TARDEC  
TWVS ATO  
Ground Systems Survivability

## Door Sag Study Background

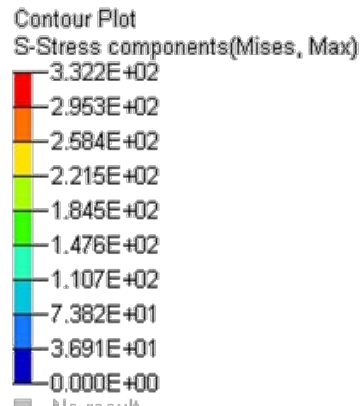
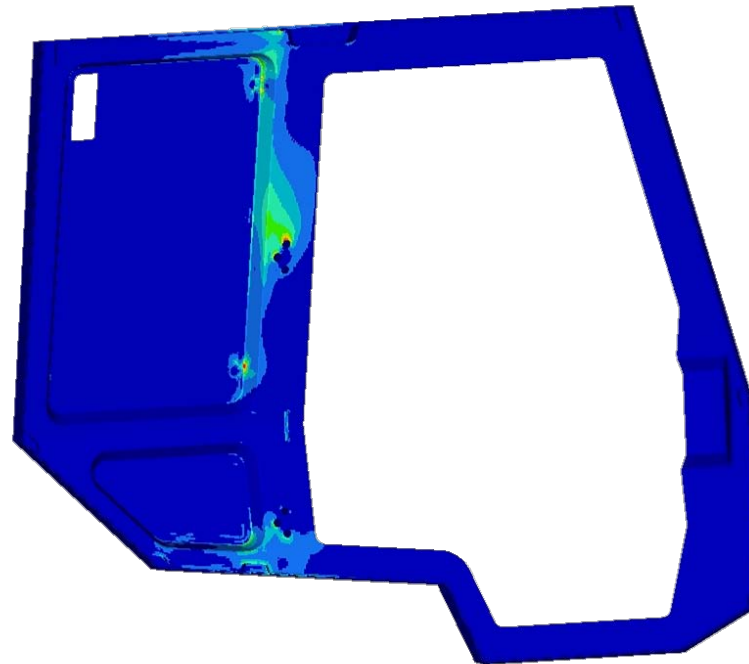
## FEA vs Measured Values - Strain

Maximum Stress = 332 MPa  
Safety Factor = 2.1

CASSI's FEA was similar to the vehicle supplier's

From the two models, locations for strain gauges were selected

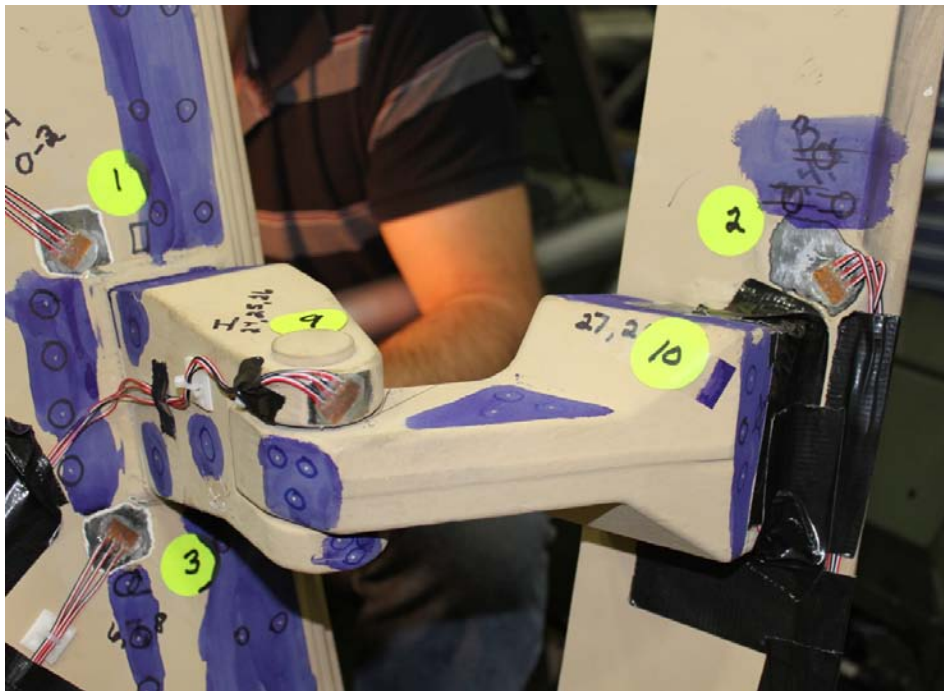
Top Hinge

Not Shown – Gauge #11 on the inside of the B-Pillar  
(roughly behind Gauge #1)

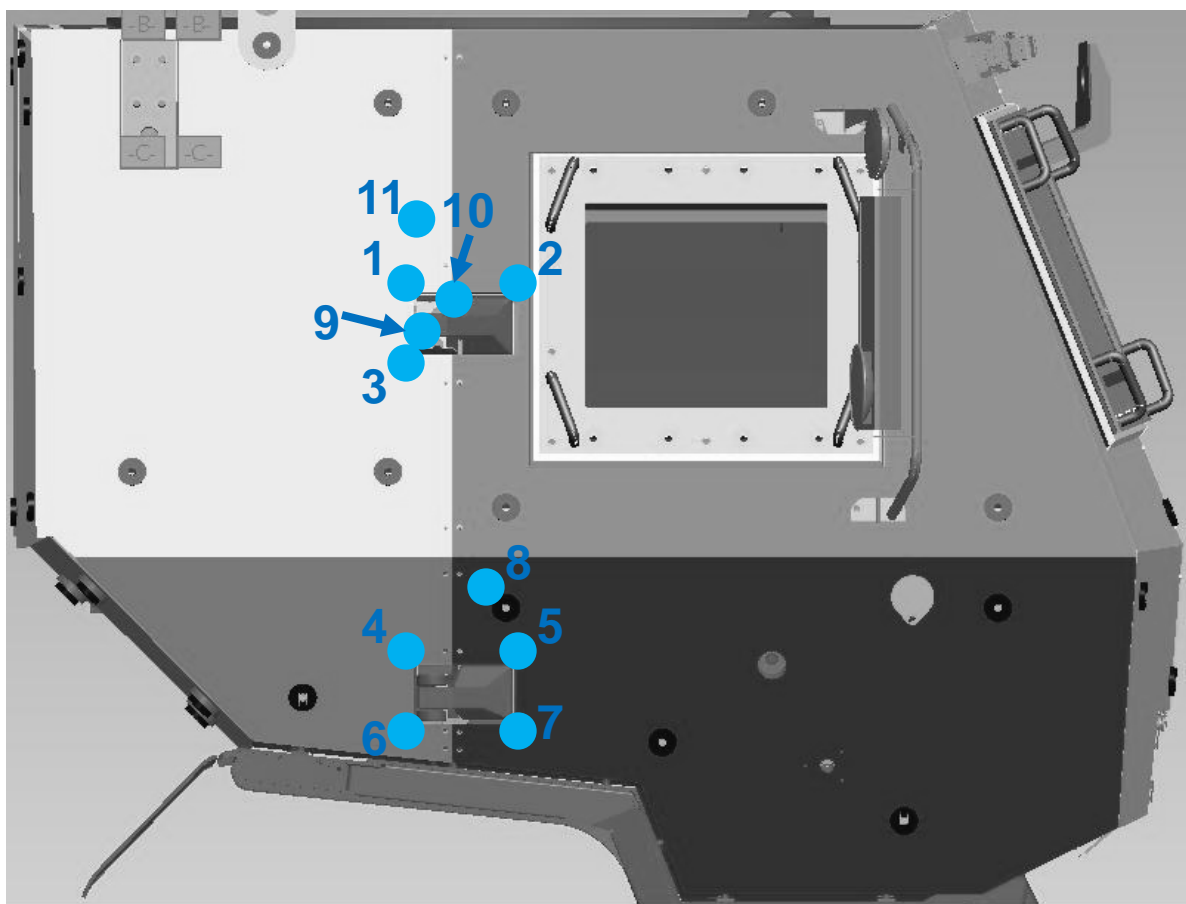
## Measured Peak Strain: A-Cab

- = 700–950  $\mu$ E
- = 450–700  $\mu$ E
- = 200–450  $\mu$ E
- = 0–200  $\mu$ E

1. Near top left corner of top hinge
2. Near top right corner of top hinge
3. Near bottom left corner of top hinge
4. Near top left corner of bottom hinge
5. Near top right corner of bottom hinge
6. Near bottom left corner of bottom hinge
7. Near bottom right corner of bottom hinge
8. Under belt line near hinge side of door
9. On the side of the top hinge
10. On the top of the top hinge
11. Inside of cab, mounted on B-pillar channel

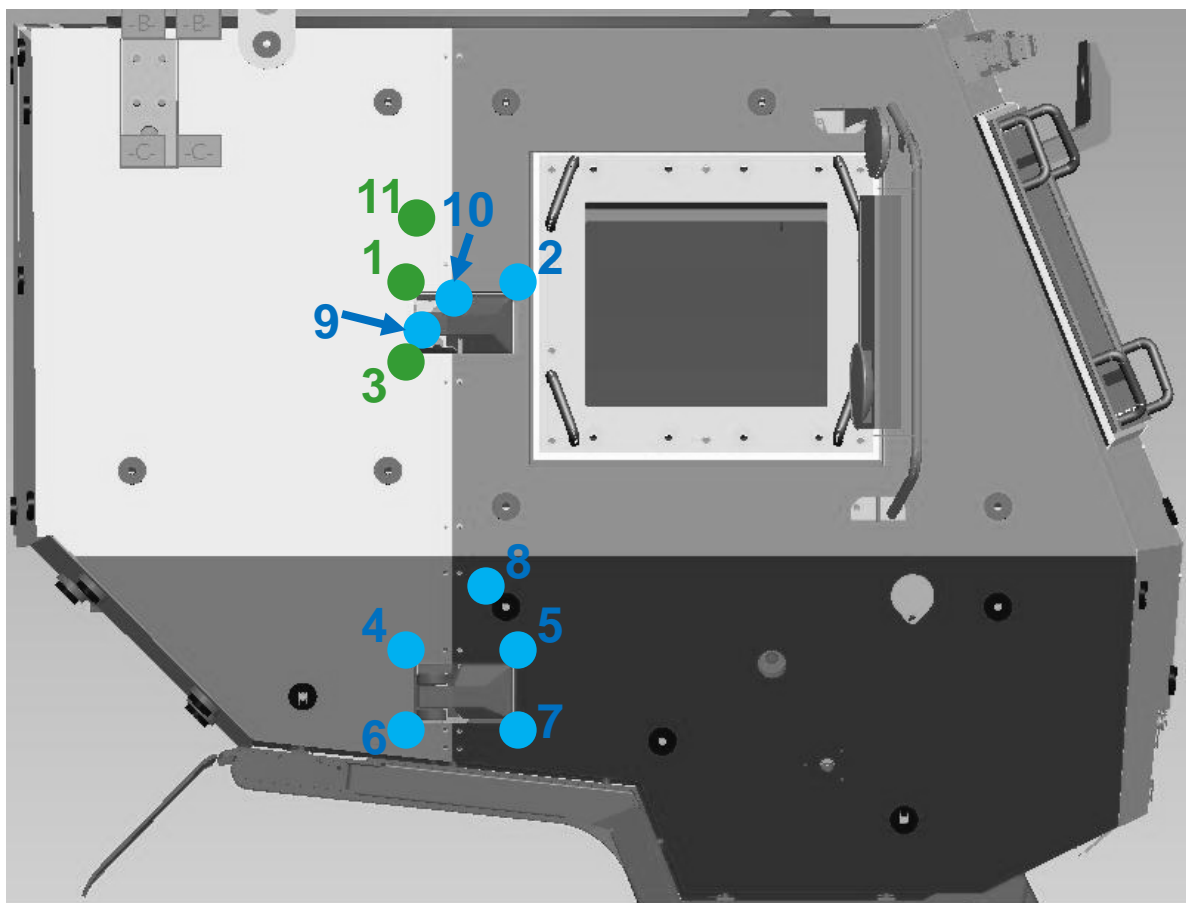
## Measured Peak Strain: w/ B-kit

- = 700–950  $\mu$ E
- = 450–700  $\mu$ E
- = 200–450  $\mu$ E
- = 0–200  $\mu$ E

1. Near top left corner of top hinge
2. Near top right corner of top hinge
3. Near bottom left corner of top hinge
4. Near top left corner of bottom hinge
5. Near top right corner of bottom hinge
6. Near bottom left corner of bottom hinge
7. Near bottom right corner of bottom hinge
8. Under belt line near hinge side of door
9. On the side of the top hinge
10. On the top of the top hinge
11. Inside of cab, mounted on B-pillar channel

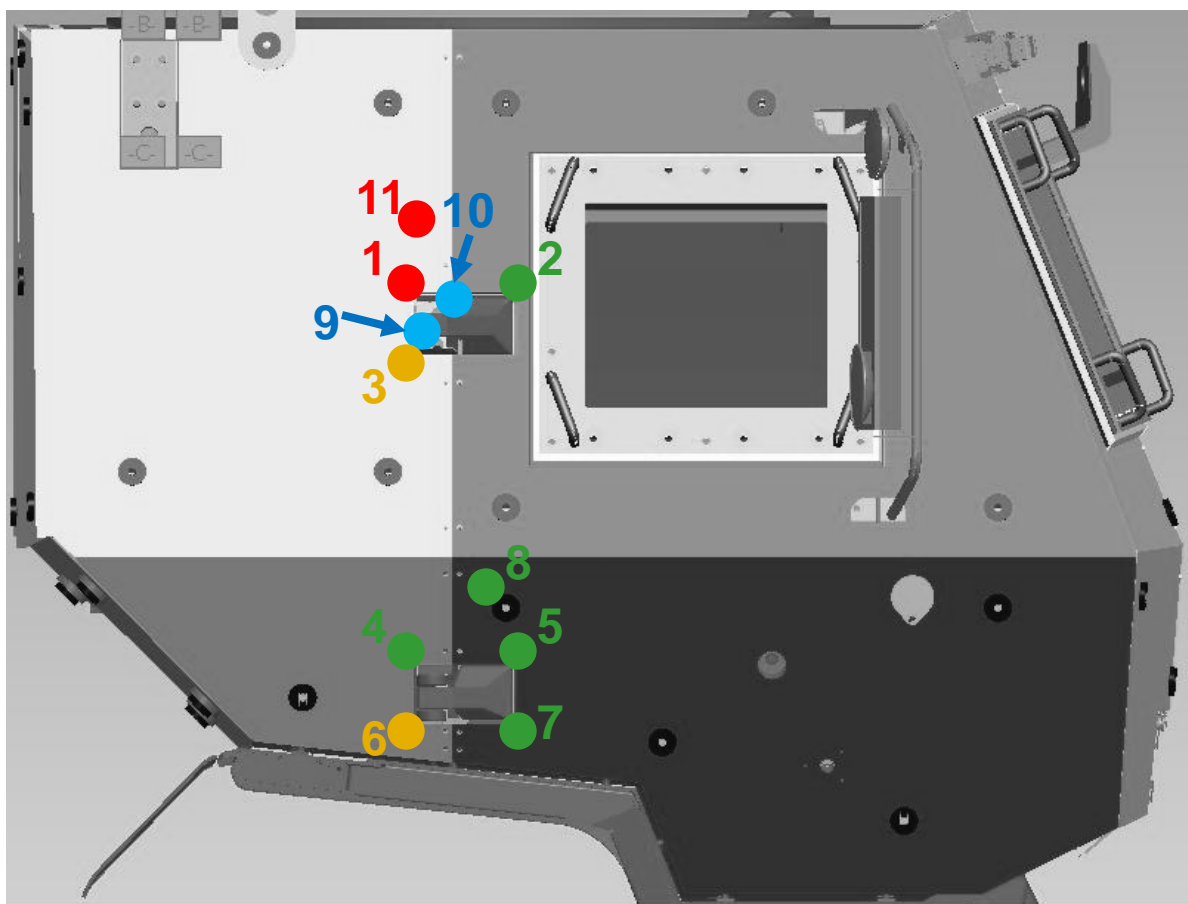
## Measured Peak Strain: w/ B-kit + C-kit

- = 700–950  $\mu$ E
- = 450–700  $\mu$ E
- = 200–450  $\mu$ E
- = 0–200  $\mu$ E

1. Near top left corner of top hinge
2. Near top right corner of top hinge
3. Near bottom left corner of top hinge
4. Near top left corner of bottom hinge
5. Near top right corner of bottom hinge
6. Near bottom left corner of bottom hinge
7. Near bottom right corner of bottom hinge
8. Under belt line near hinge side of door
9. On the side of the top hinge
10. On the top of the top hinge
11. Inside of cab, mounted on B-pillar channel

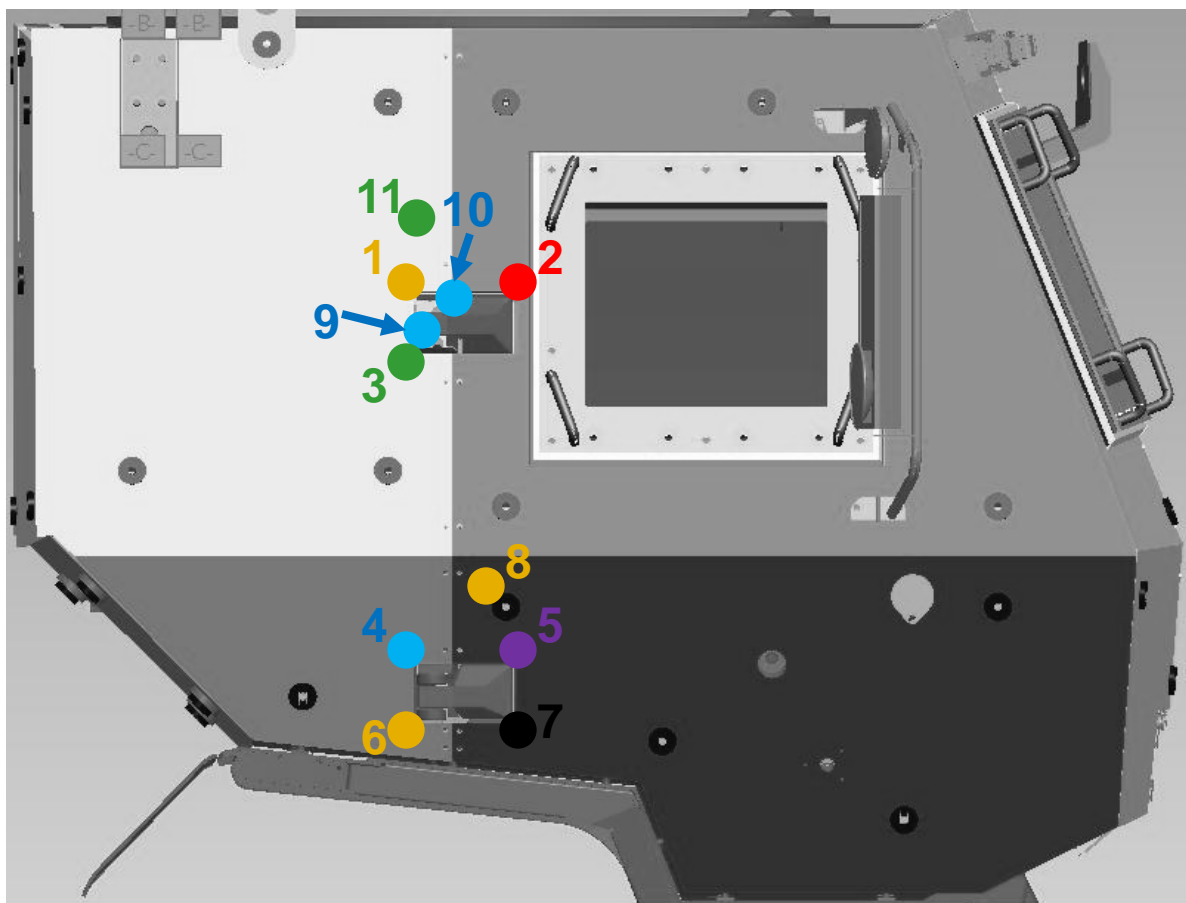
## Measured Peak Strain: Post Shaker w/ B-kit + C-kit

● = 950-3050  $\mu$ E

● = 700-950  $\mu$ E

● = 450-700  $\mu$ E

● = 200-450  $\mu$ E

● = 0-200  $\mu$ E

● = Damaged

1. Near top left corner of top hinge
2. Near top right corner of top hinge
3. Near bottom left corner of top hinge
4. Near top left corner of bottom hinge
5. Near top right corner of bottom hinge
6. Near bottom left corner of bottom hinge
7. Near bottom right corner of bottom hinge
8. Under belt line near hinge side of door
9. On the side of the top hinge
10. On the top of the top hinge
11. Inside of cab, mounted on B-pillar channel

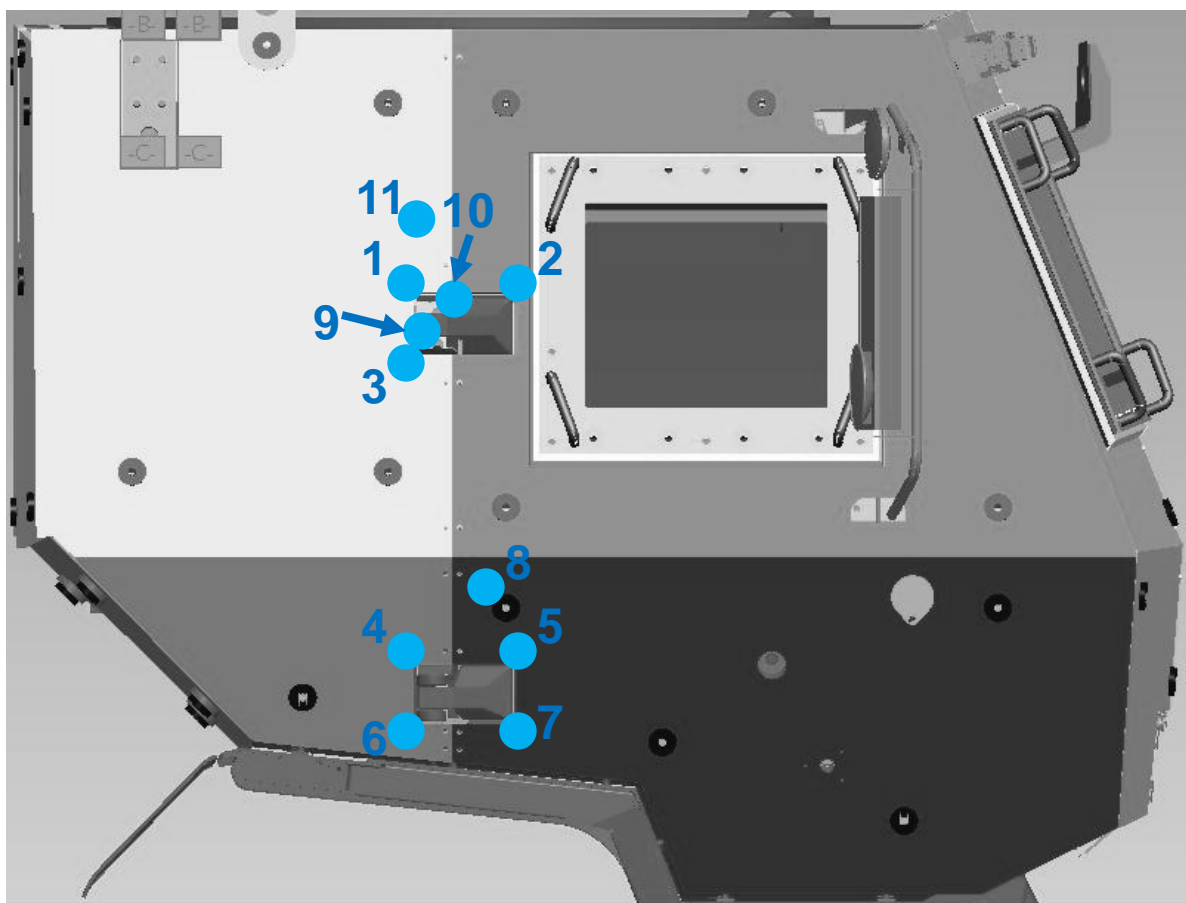
## Measured Peak Strain: Post Shaker A-Cab

- = 700–950  $\mu\text{E}$
- = 450–700  $\mu\text{E}$
- = 200–450  $\mu\text{E}$
- = 0–200  $\mu\text{E}$

1. Near top left corner of top hinge
2. Near top right corner of top hinge
3. Near bottom left corner of top hinge
4. Near top left corner of bottom hinge
5. Near top right corner of bottom hinge
6. Near bottom left corner of bottom hinge
7. Near bottom right corner of bottom hinge
8. Under belt line near hinge side of door
9. On the side of the top hinge
10. On the top of the top hinge
11. Inside of cab, mounted on B-pillar channel

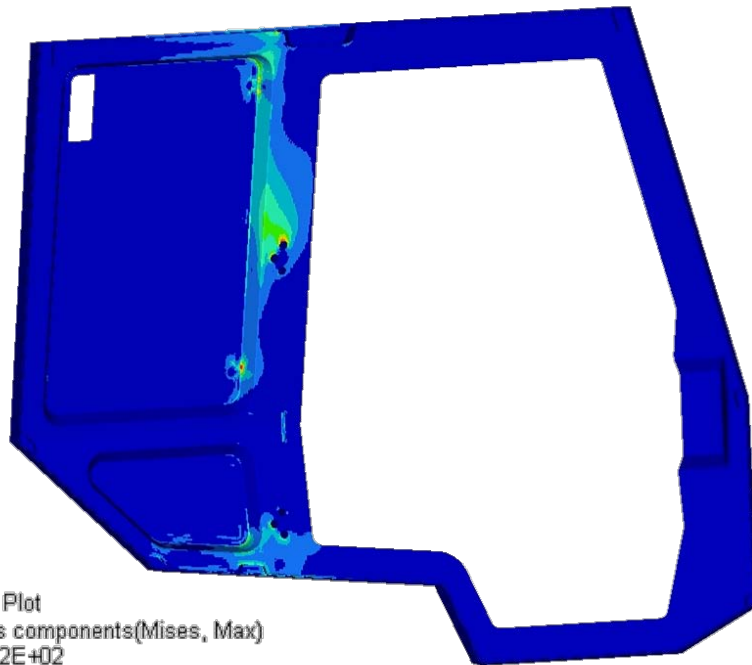
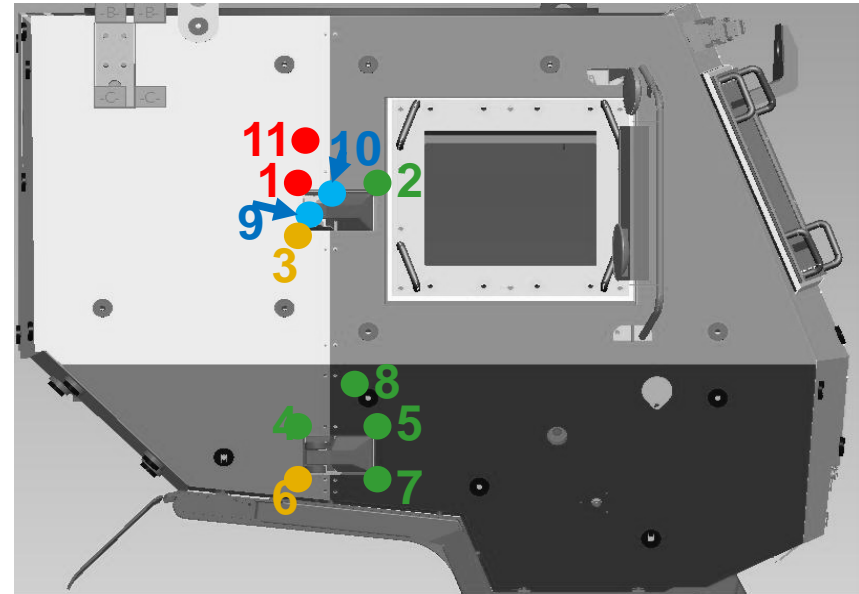
## FEA vs Measured Values – Strain with both B- and C-kits

Contour Plot  
S-Stress components(Mises, Max)

Maximum Stress = 332 MPa

Safety Factor = 2.1

- = 700–950  $\mu$ E
- = 450–700  $\mu$ E
- = 200–450  $\mu$ E
- = 0–200  $\mu$ E

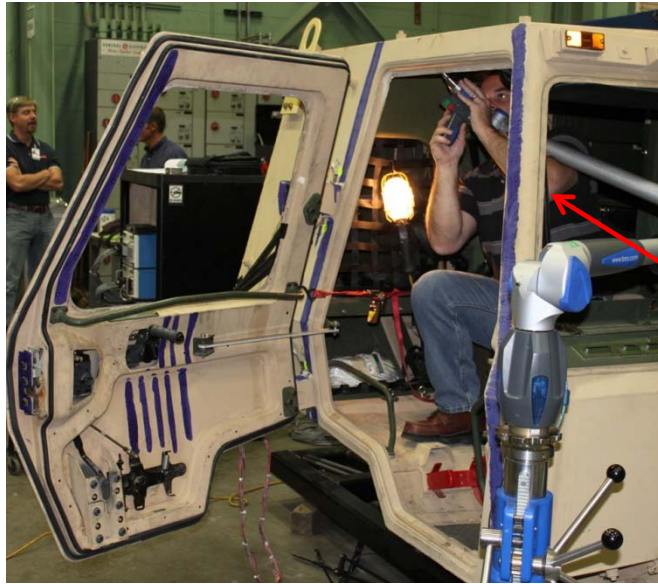
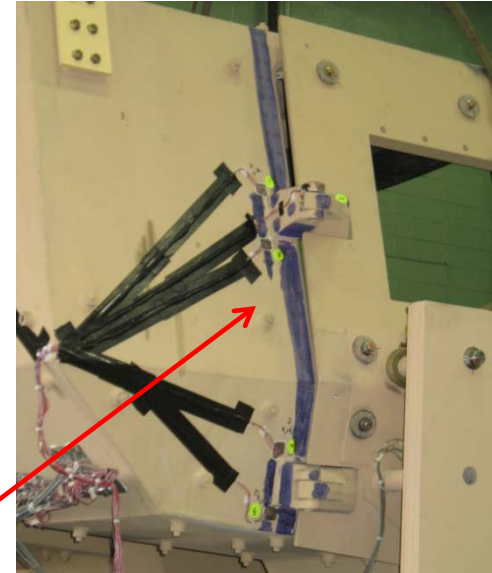
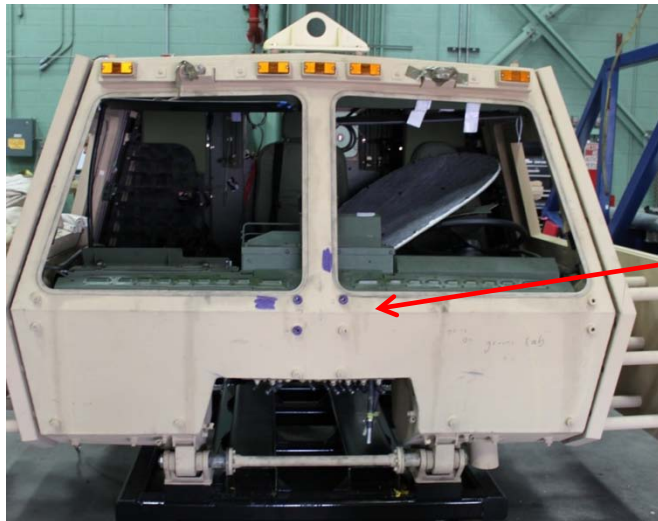
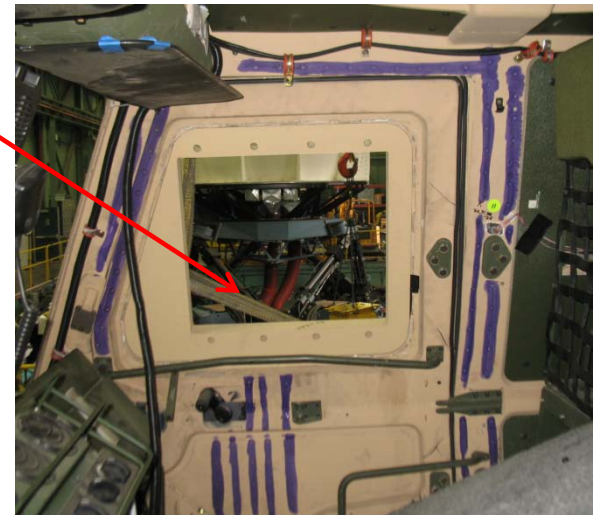
Probe Arm 3D  
Data Collection  
Points

A-Pillar

B-Pillar And Hinges

Door And Inside Cab

Reference Points

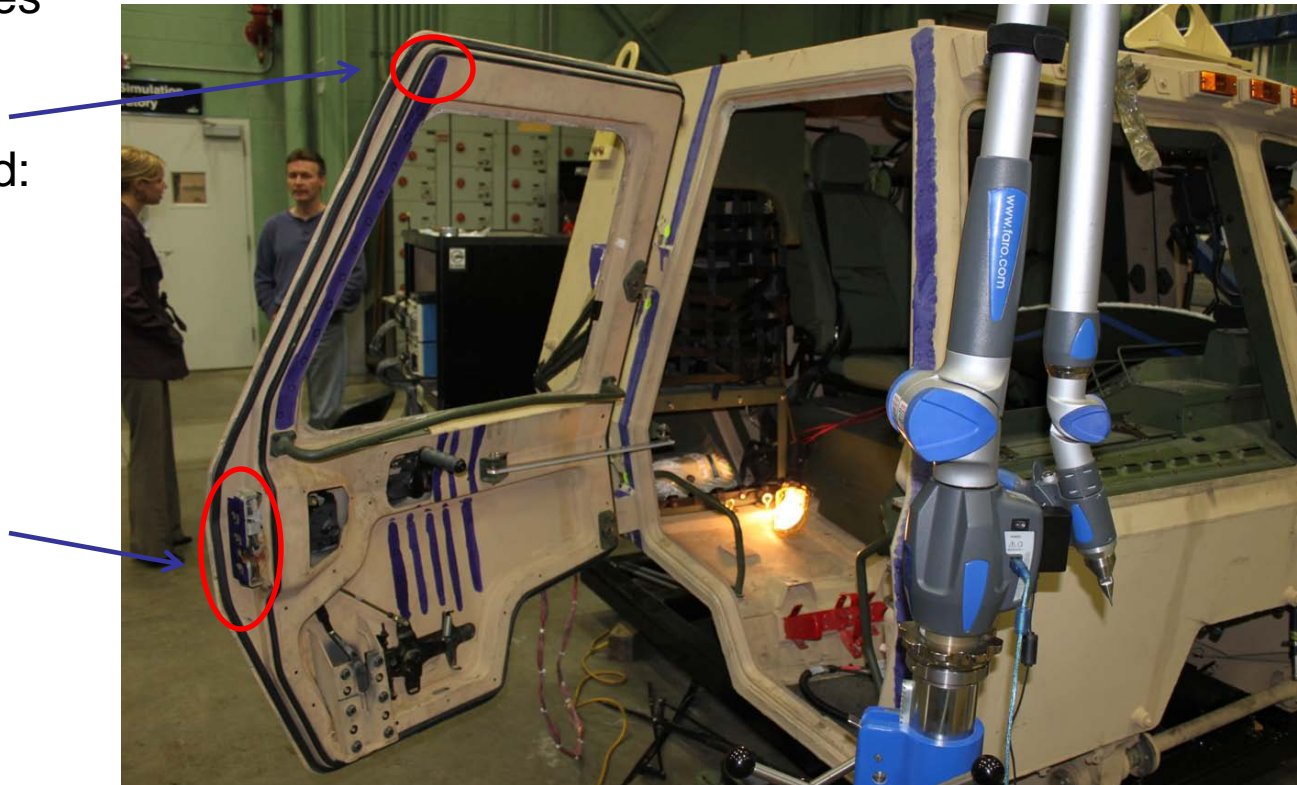
Quantify Sag At 10 Degrees Open

- Top Corner of Door Moved:
  - 0.27 in. Down
  - 0.23 in. Forward
  - 0.28 in. Outboard
- Latch Moved:
  - 0.32 in. Down

Contribution of each measured part to overall sag of the door

- A-Pillar – negligible
- B-Pillar – 20% (Deflected Outboard)
- Hinges – 60% (Top Hinge is Opening Up Slightly and Designed Clearances at Pivot Allow for Movement)
- Door Structure – 20% (Deflection at Hinge Attachments and Twisting)

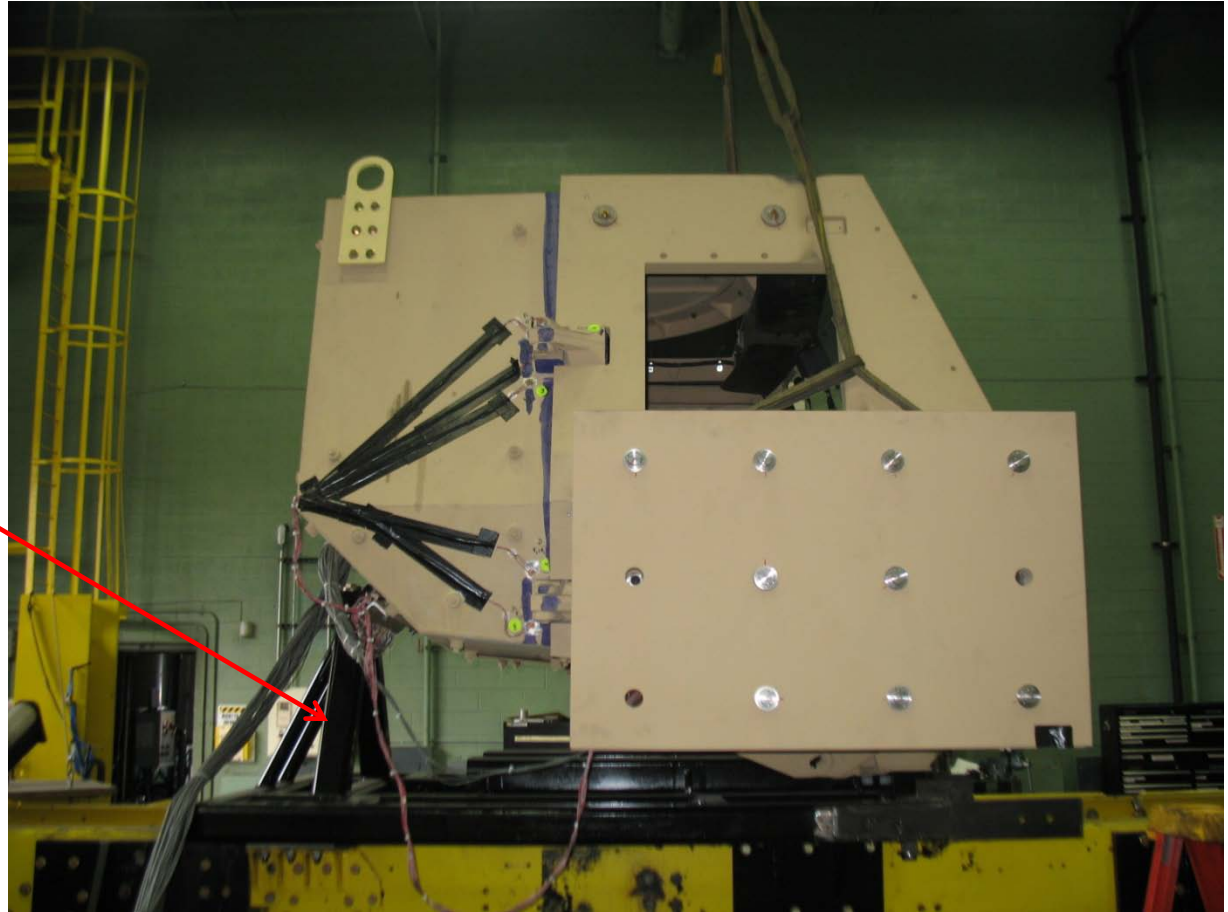
# Shaker Test

TARDEC Designed and Fabricated A Fixture To Mount An MTV Cab To The Load Handling Simulator For Shaker Tests.

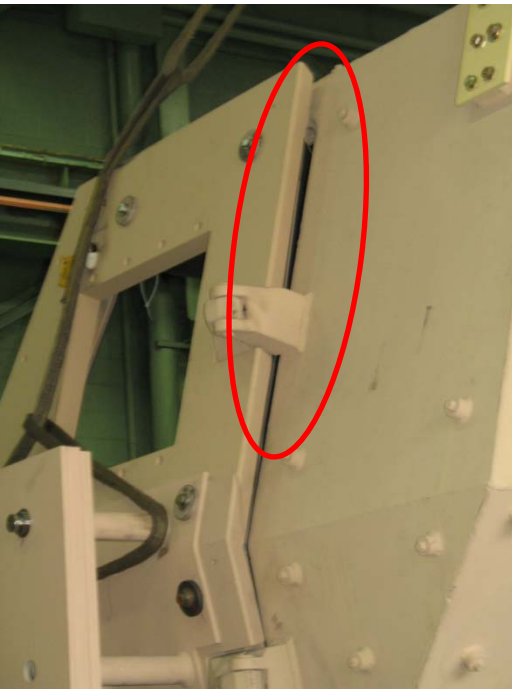
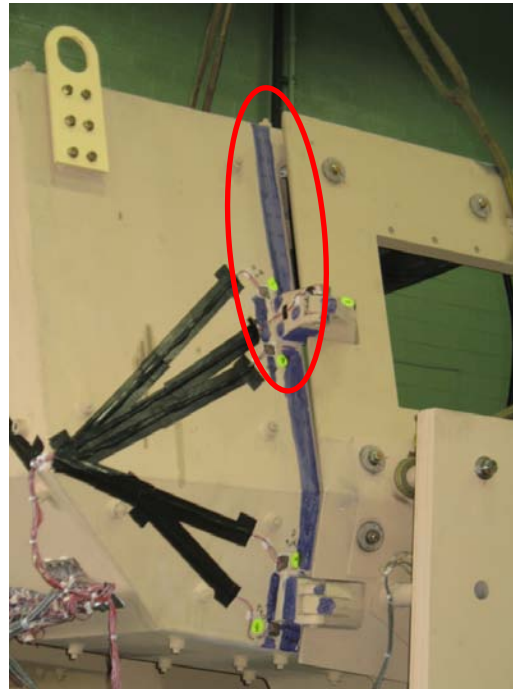
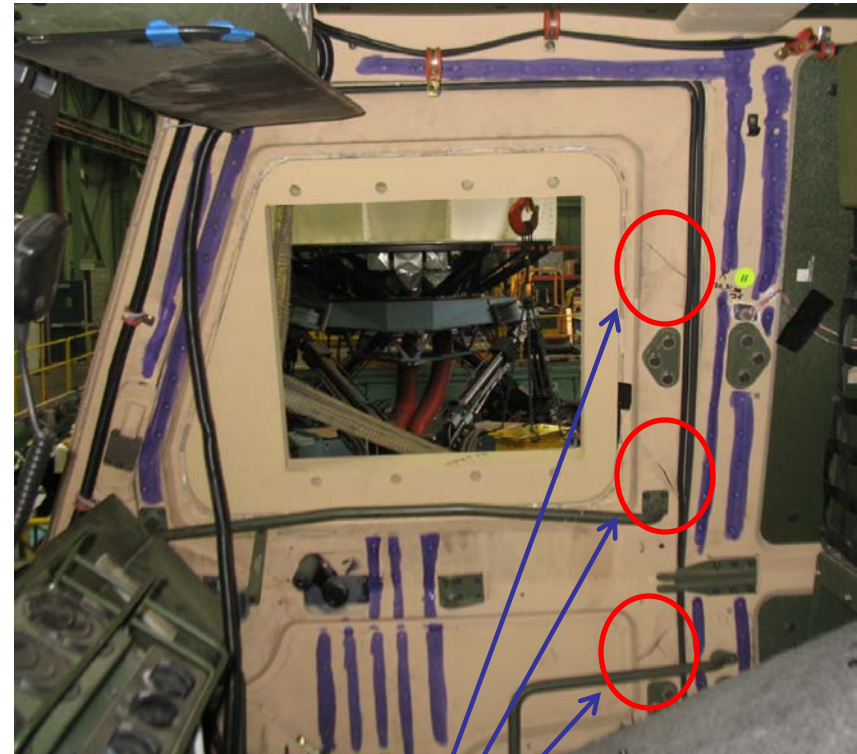
## After Shaker Test (Aborted After 160 Miles)

Note: Doors were not fully latched, only one combat lock was engaged, and no door assist was included.

Cracks near hinge attachments

- Conduct Hinge Layout After All Testing
- Next Generation Hinge Needs To Be Larger With Tighter Tolerances At Pivot Point
- Strengthen B-Pillar and Door Near Hinge Attachment Points
- More Robust/Multiple Striker Strategy (Bank Vault)
- Improve FEA Analysis to Include Hinge and Door Components
- Conduct Similar Studies (FEA and Physical) on Other TWV's
